Super Salvage, Inc.
Industrial Stormwater Inspection Report

Appendix B

Photograph Log and Photographs

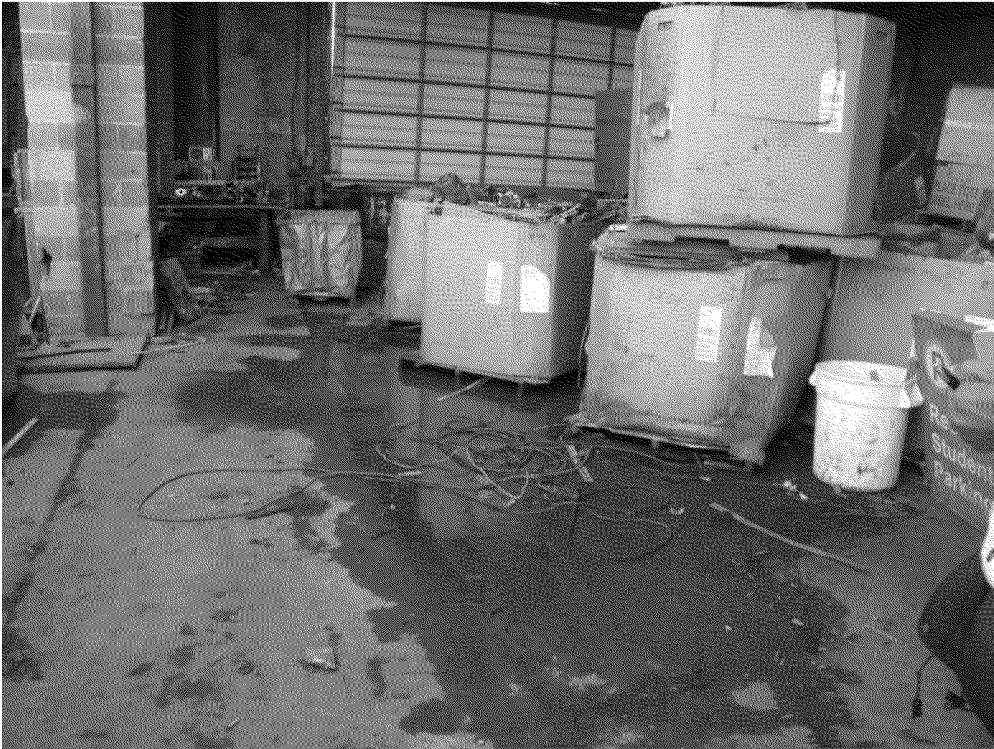
Photograph 33. Heavy staining on the concrete floors.

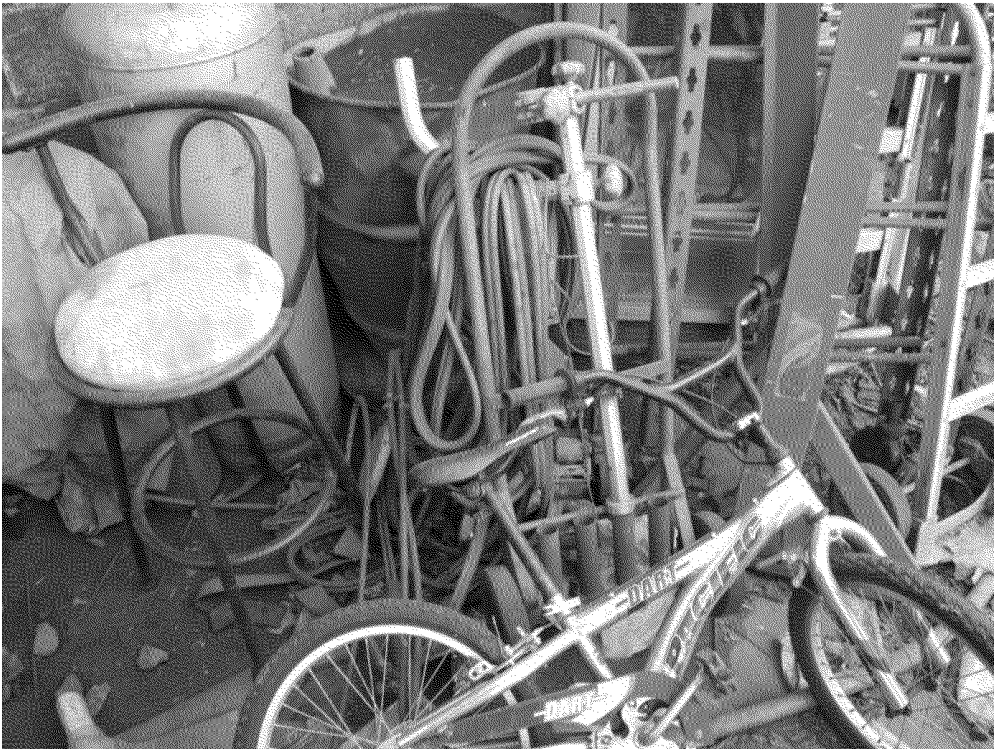
Photograph 34. Debris adjacent to the large runoff collection pond.

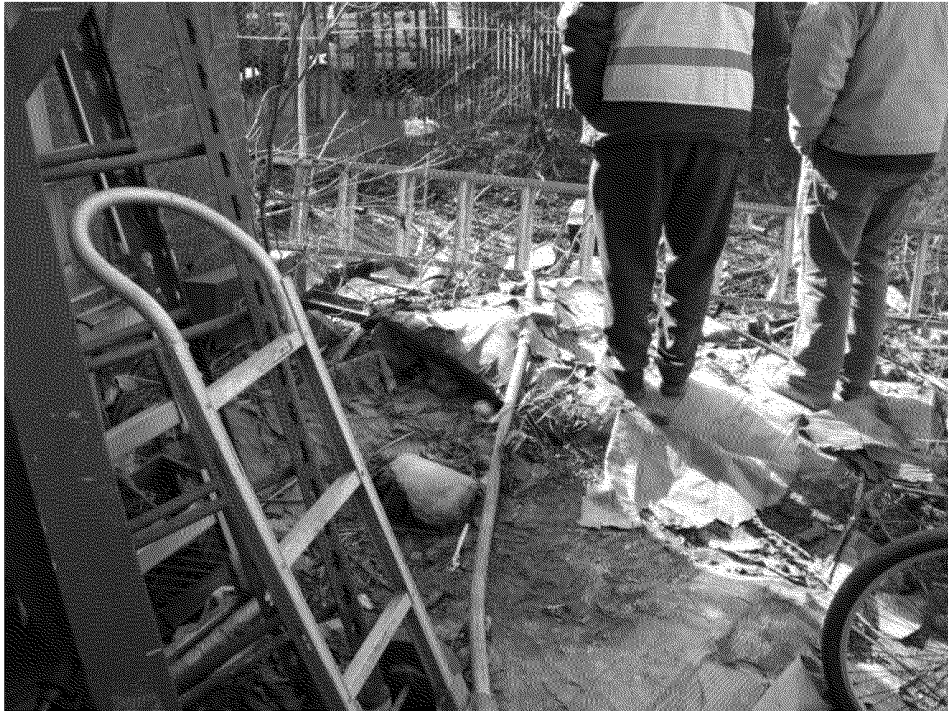
Photograph 35. Red hose leading from the manual pump in the small runoff collection pond to the large runoff collection pond.

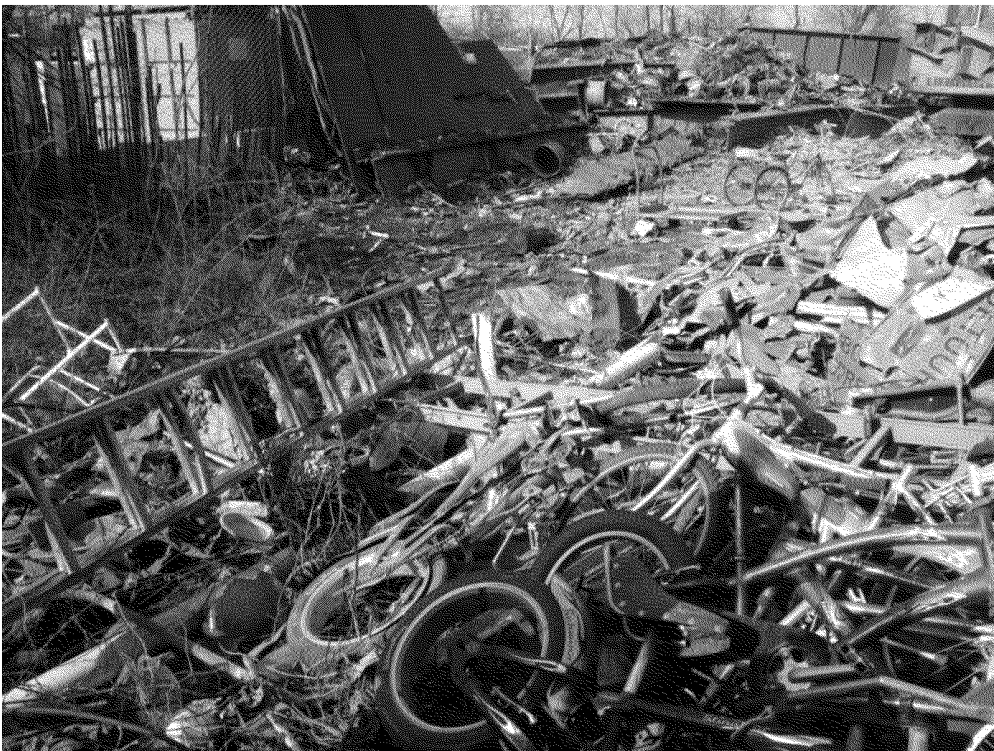
Photograph 36. View of debris just right of the large runoff collection pond.

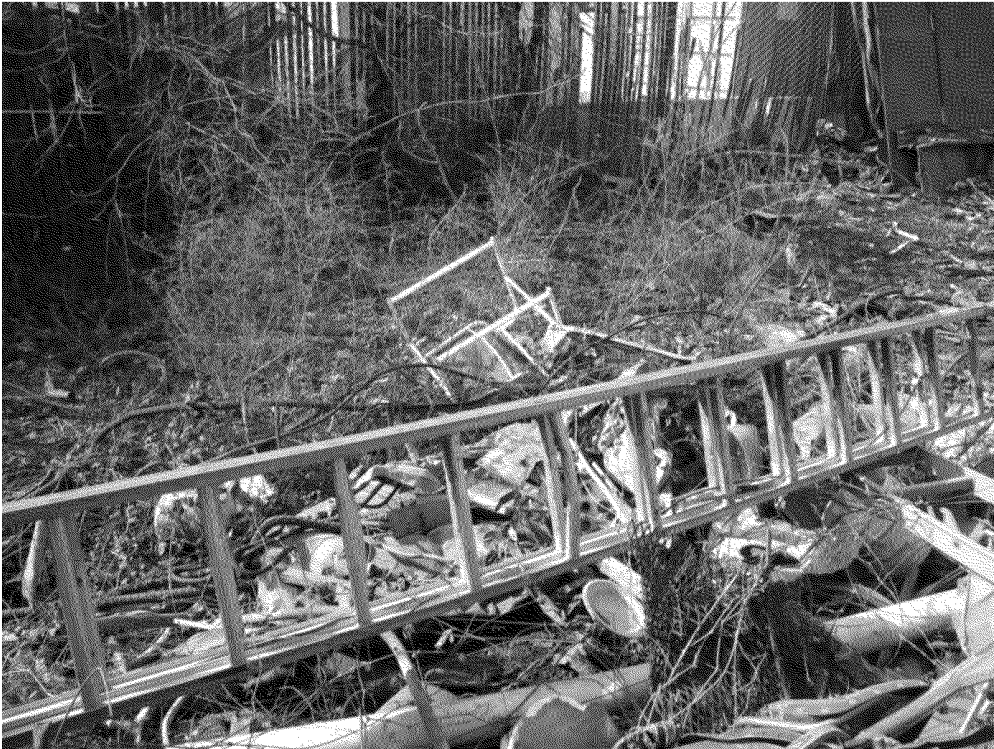
Photograph 37. **Alternate view of debris adjacent to the large runoff collection pond.**

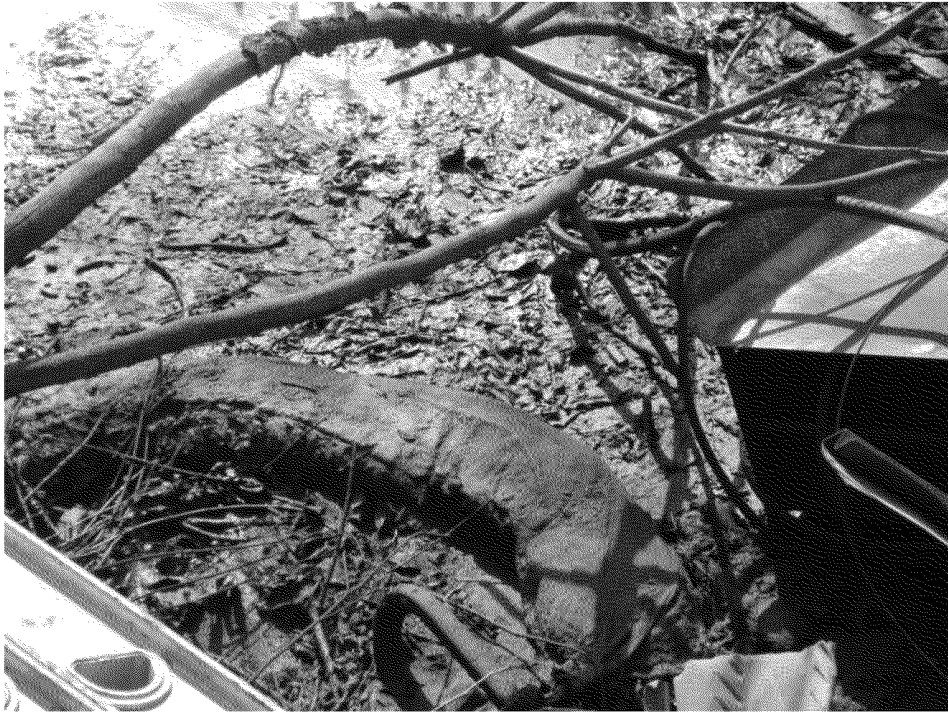
Photograph 39. Saturated absorbent sock at the northern end of the large runoff collection pond.

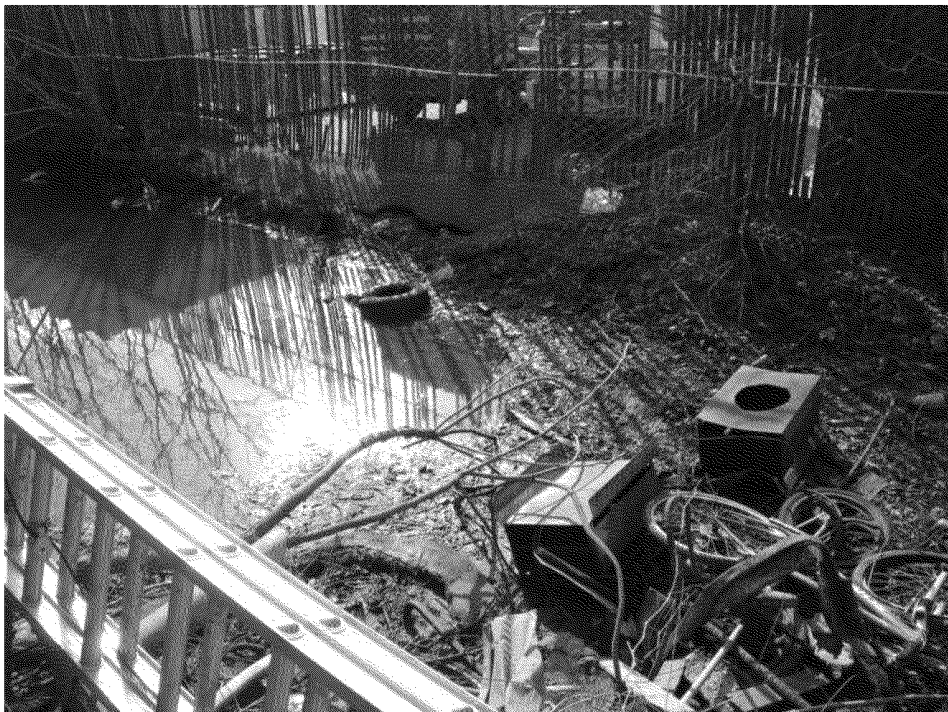
Photograph 40. Alternate view of the absorbent sock relative to the northern end of the large runoff collection pond.

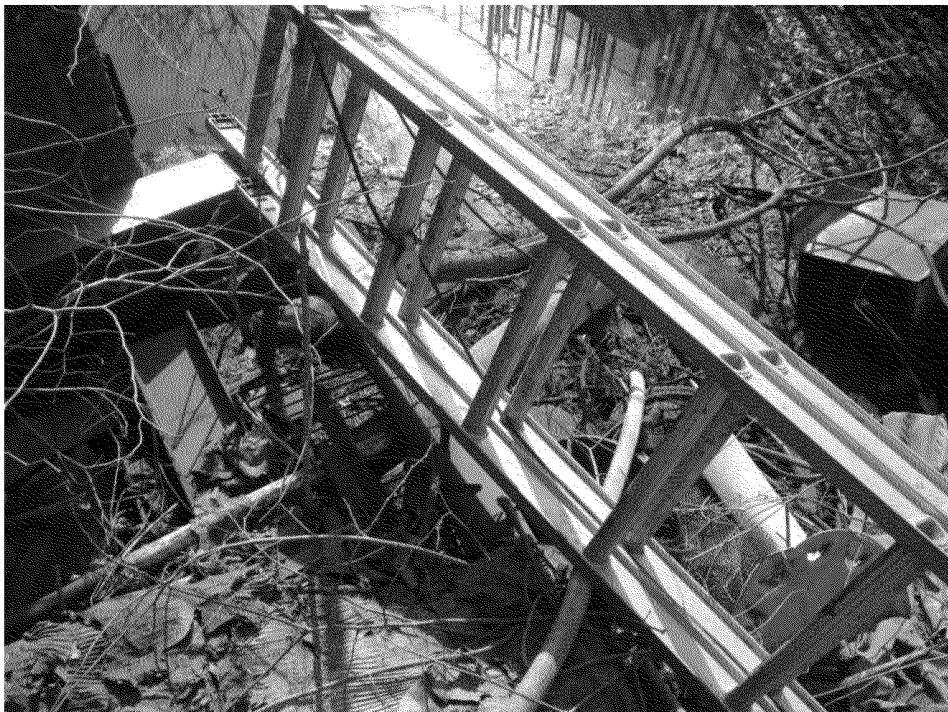
Photograph 42. Alternate view of the absorbent sock at the northern end of the large runoff collection pond.

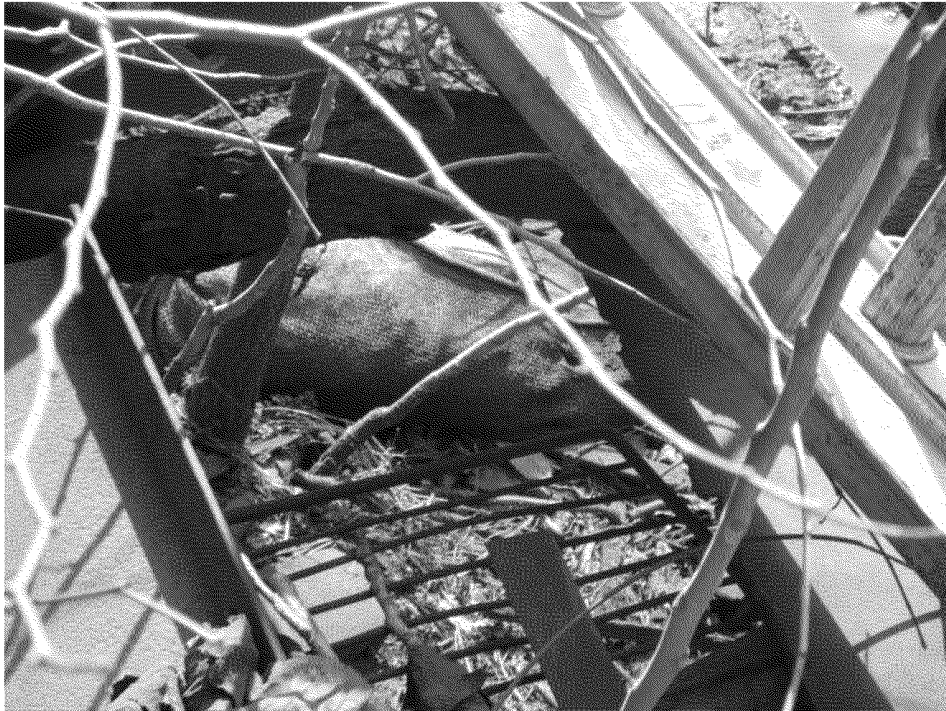
Photograph 43. Close-up view of the absorbent sock with orange indicating its original color at the northern end of the large runoff collection pond.

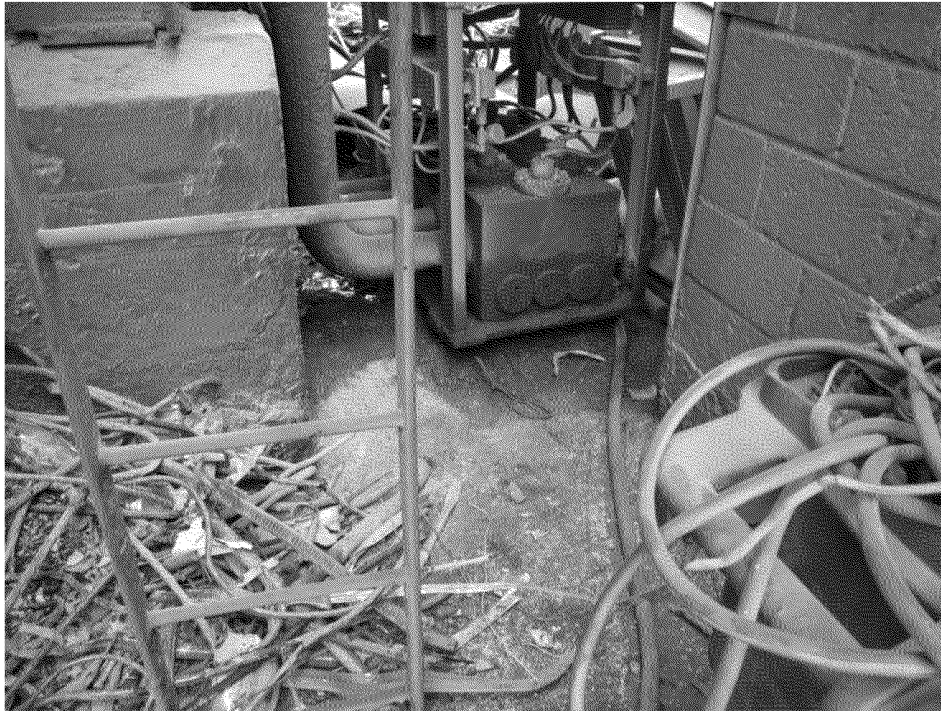
Photograph 45. Fluid leaking from under the conveyor belt of the “crusher” .

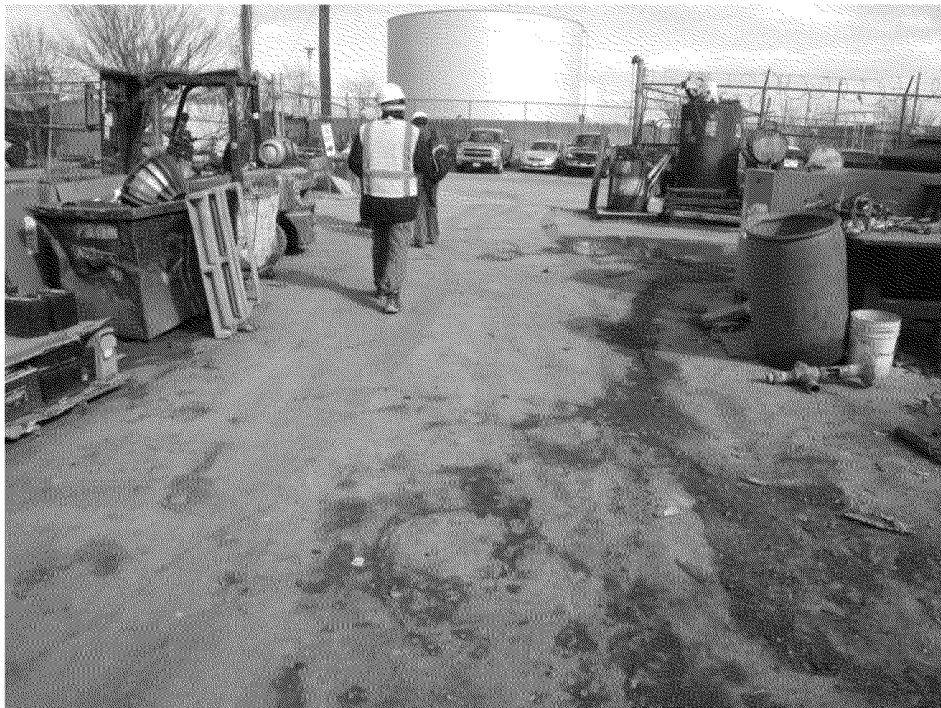
Photograph 46. View of Entrance 1 from the inside the yard showing staining on the ground.

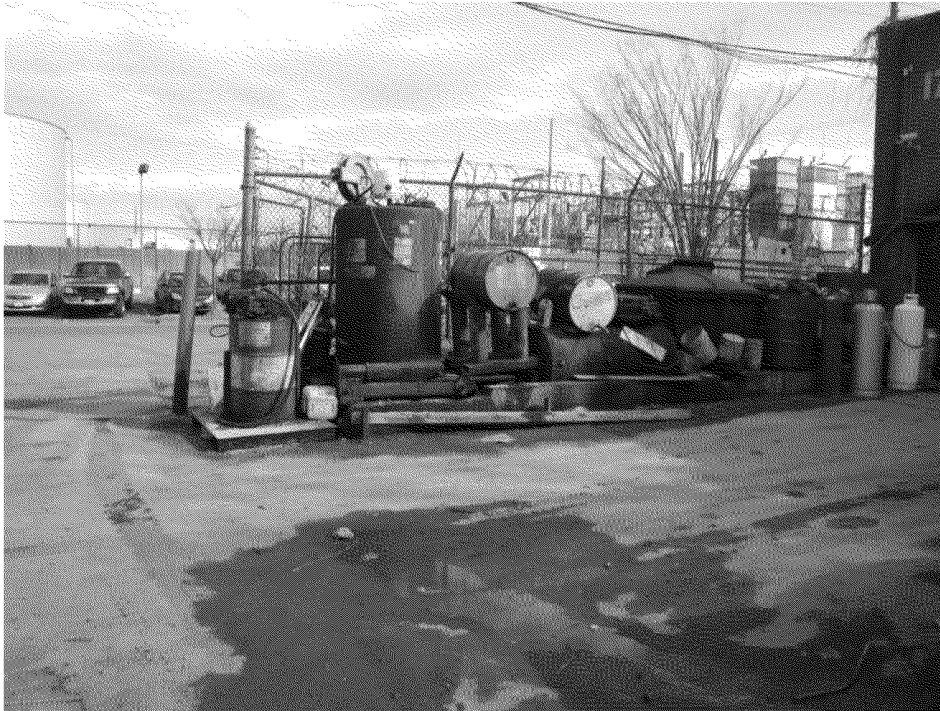
Photograph 47. Overall view of the oil drums stored near Entrance 1.

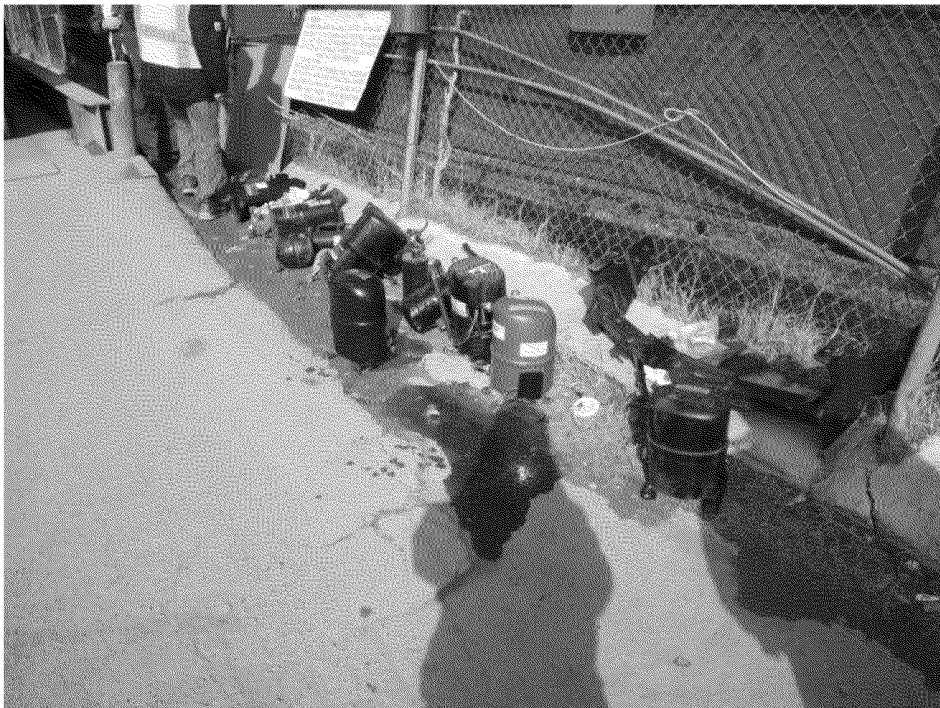
Photograph 48. Air conditioning units, some leaking fluids.

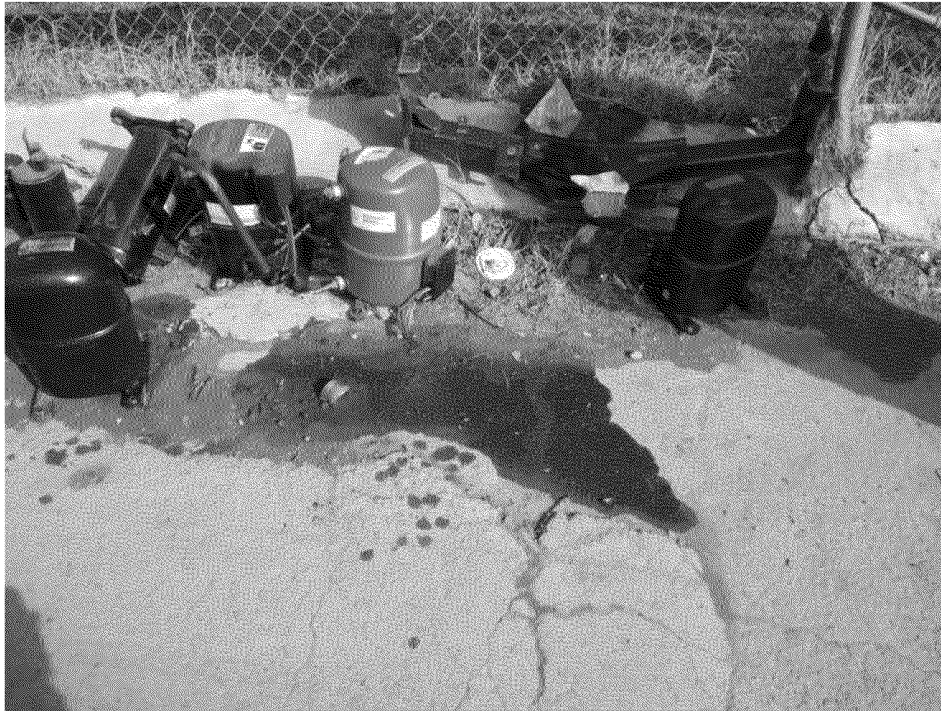
Photograph 49. Close-up view of the air conditioning units from Photograph 48.

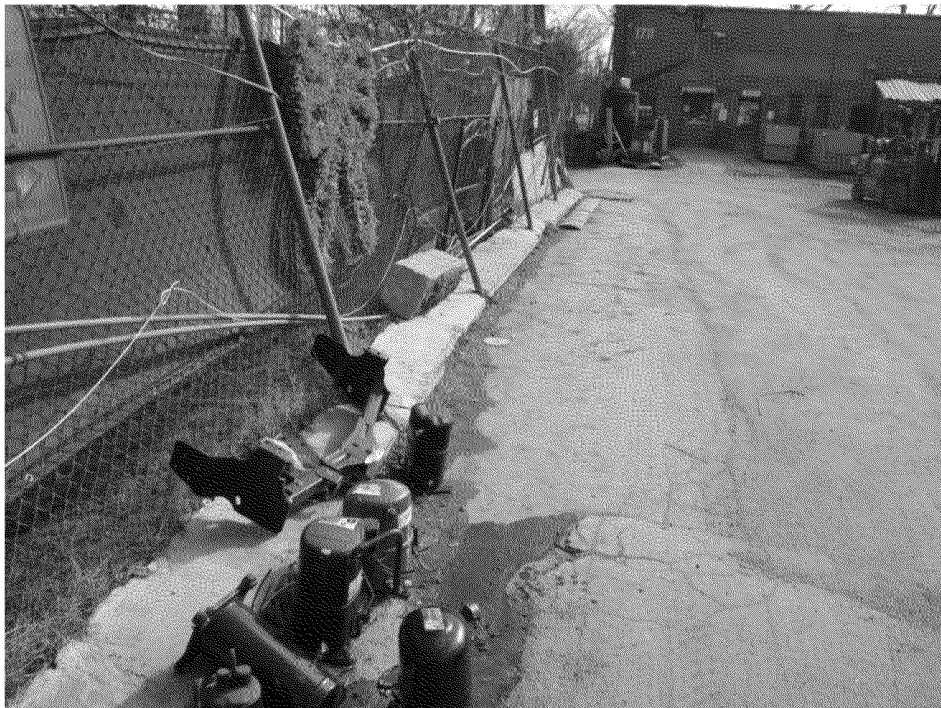
Photograph 50. View of the facility perimeter towards Entrance 1 including air conditioning units from Photograph 48.

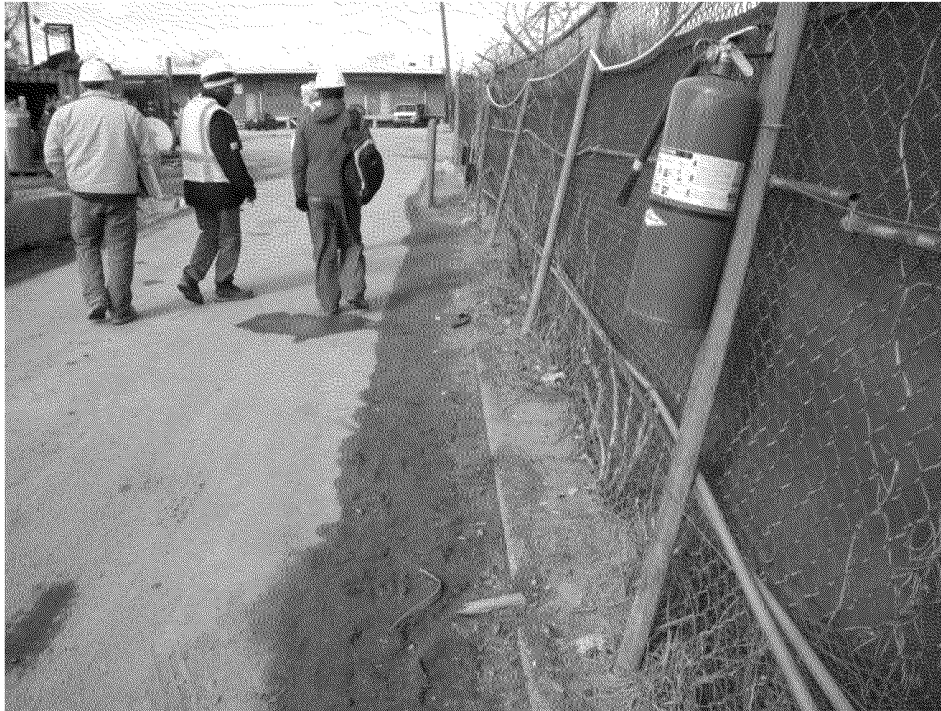
Photograph 51. **Alternate view of the perimeter towards Entrance 2.**

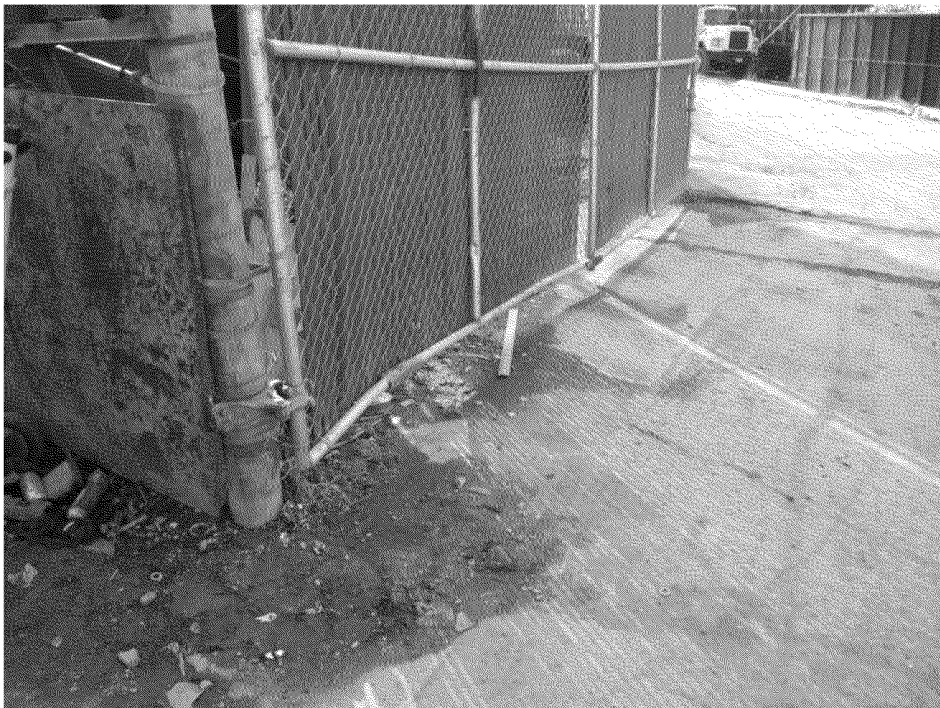
Photograph 56. Staining passing under the property fence onto the District of Columbia (DC) property near Entrance 2.

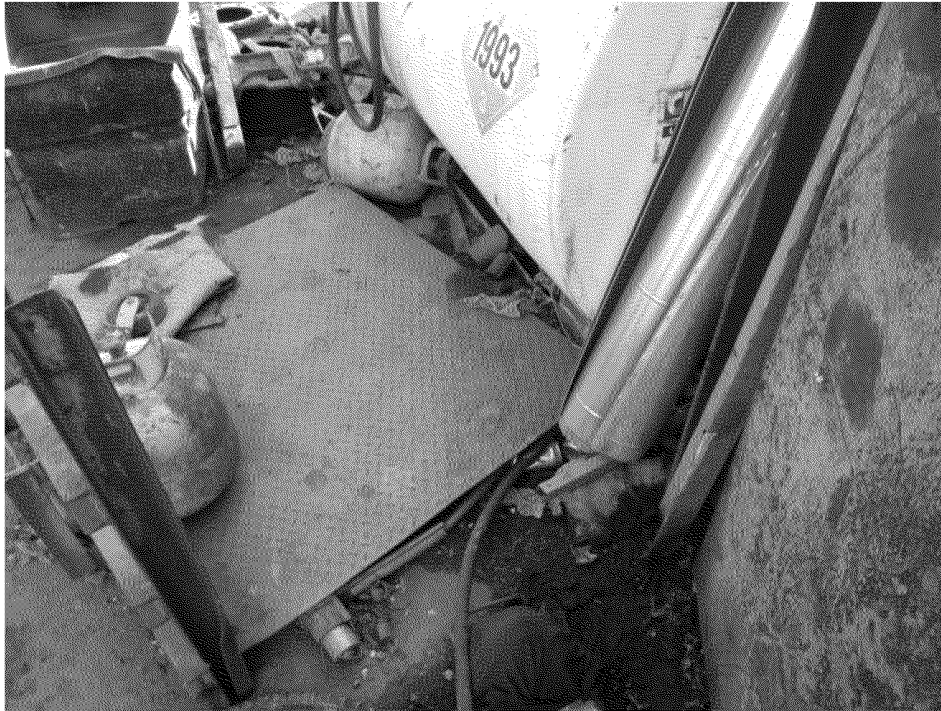
Photograph 57. Scrapped propane tanks stored near 500-gallon fuel tank.

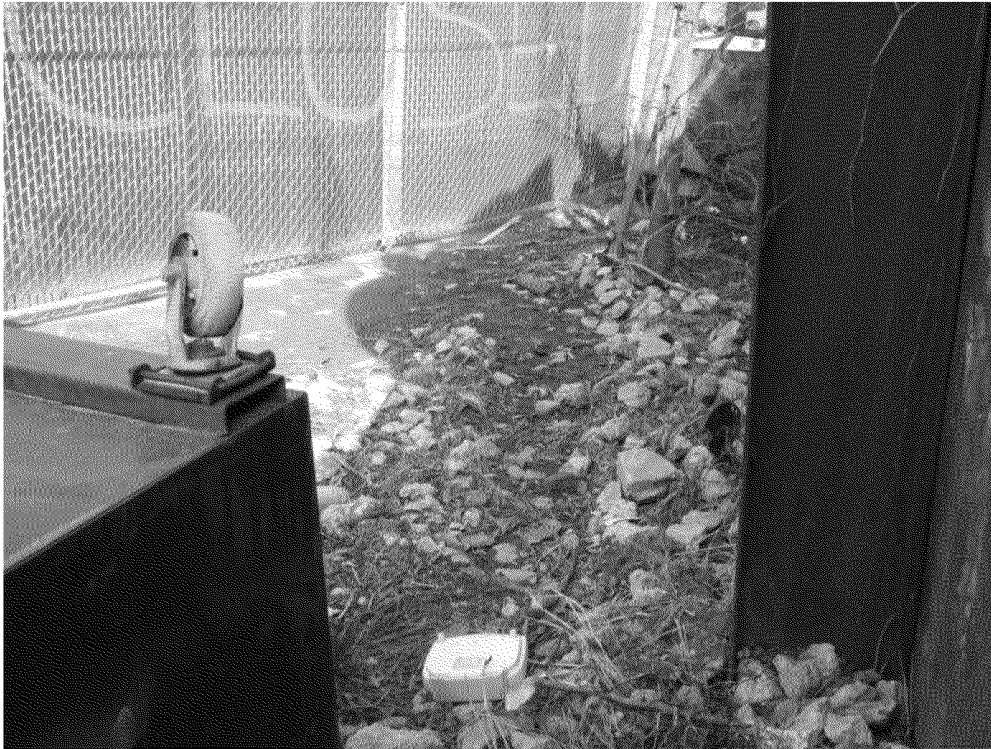
Photograph 59. View of debris around Entrance 2 and staining on the ground.

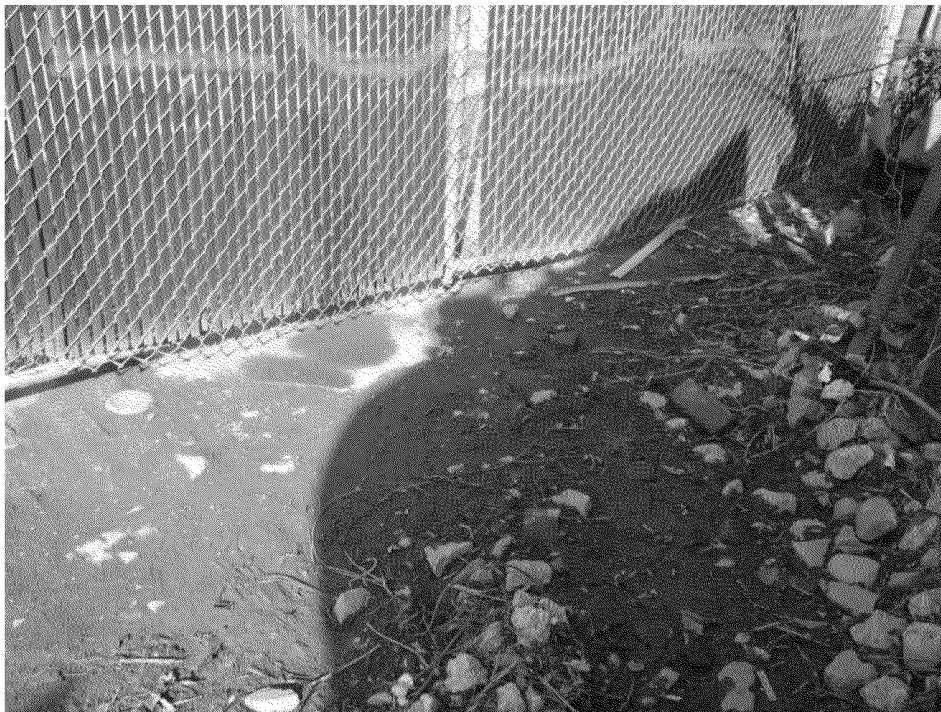
Photograph 60. Alternate view of Entrance 2 to show the staining is not due to shadows.

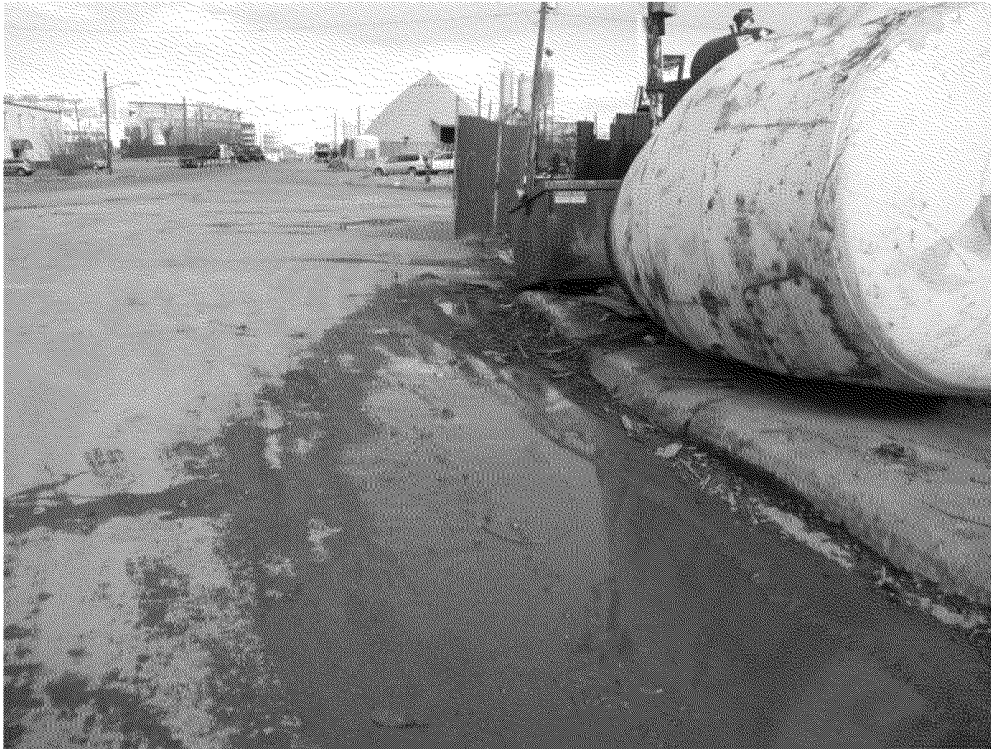
Photograph 61. Sediment residue on streets outside Entrance 2.

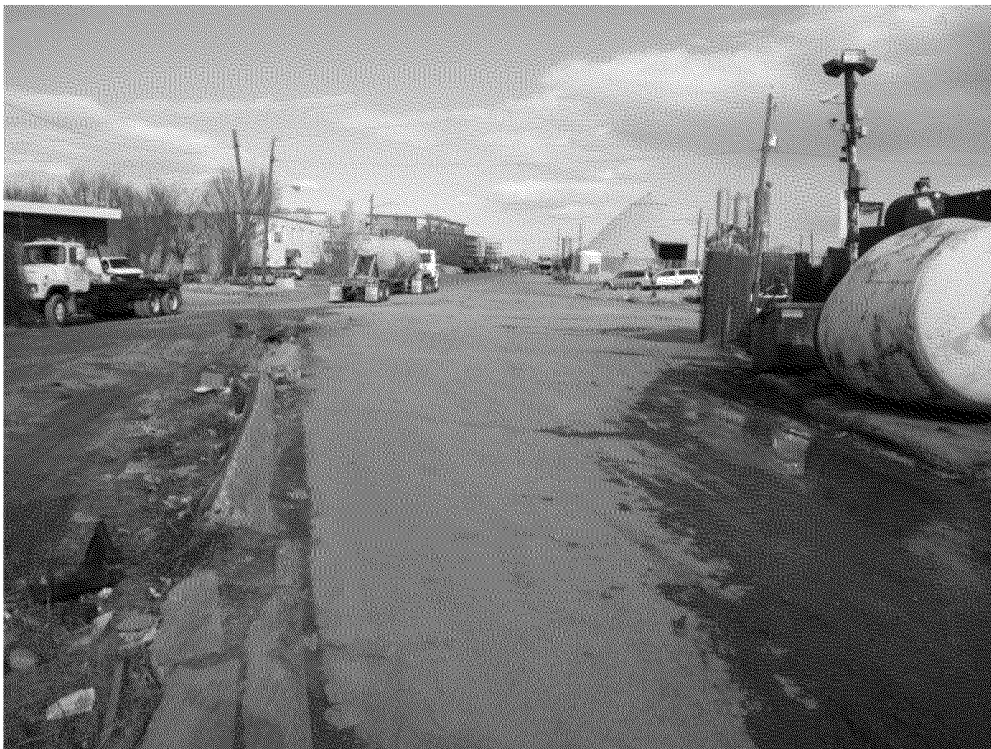
Photograph 62. Alternate view of sediment residue around Entrance 2.

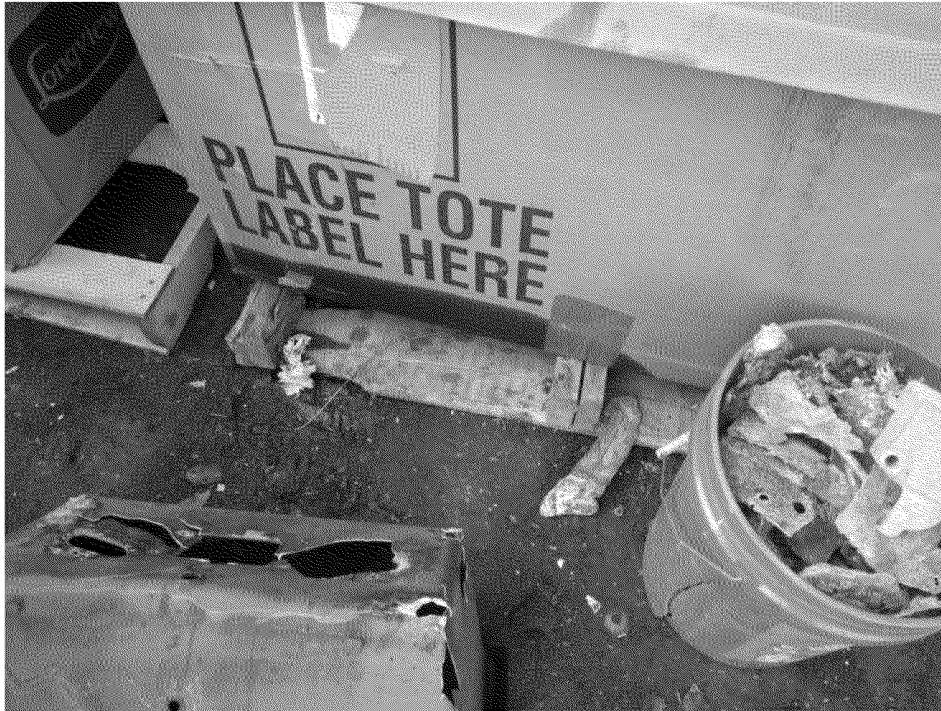
Photograph 65. Box from Photograph 66 with staining on the outside.

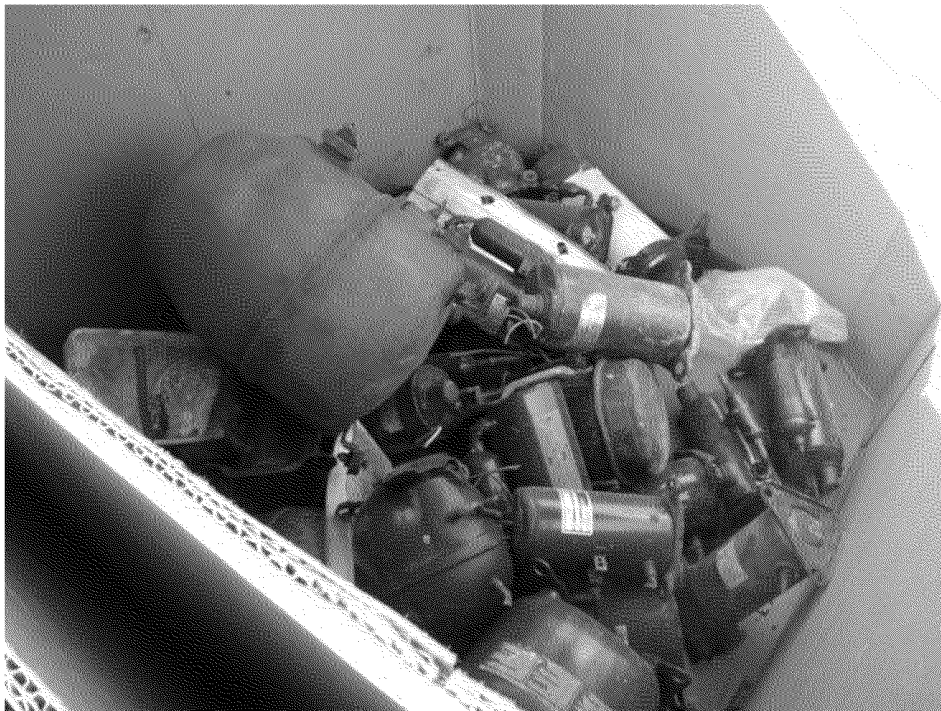
Photograph 66. View of inside of box with staining shown in Photograph 65. Box contains engine parts.

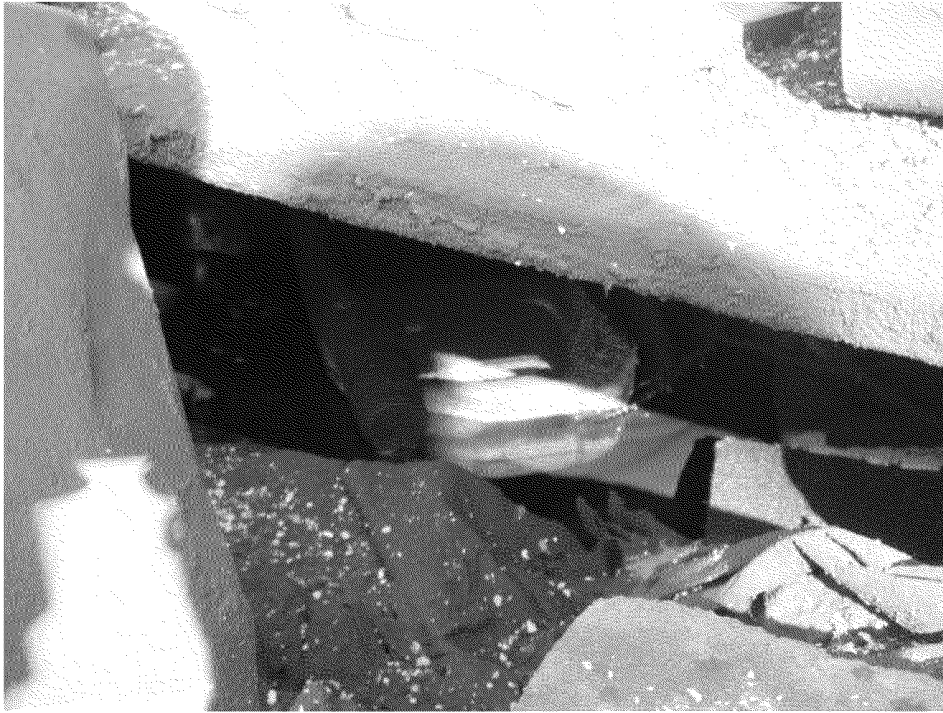
Photograph 67. Close-up view of what appears to be oil pooled under tanks near Entrance 1.

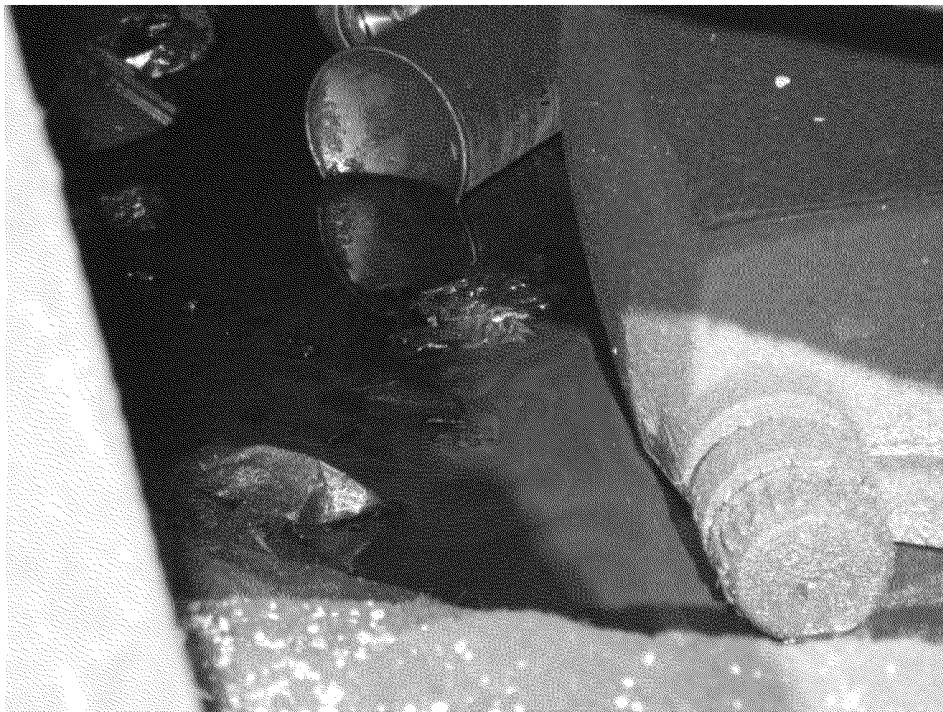
Photograph 68. Close-up view of what appears to be oil pooling under tanks.

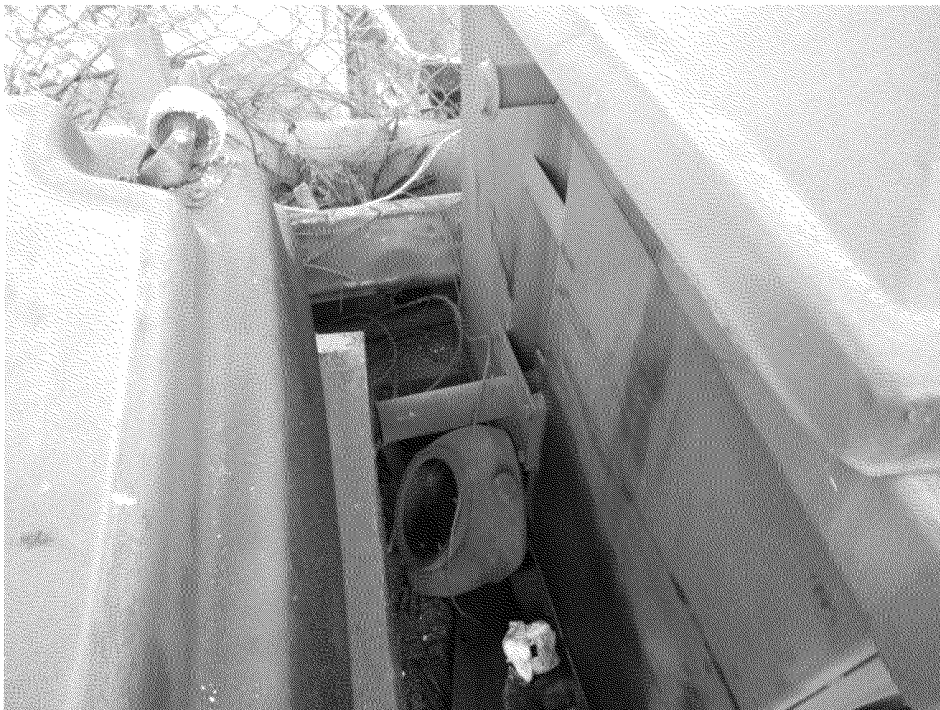
Photograph 72. Alternate view of container from Photograph 71 showing exterior staining.

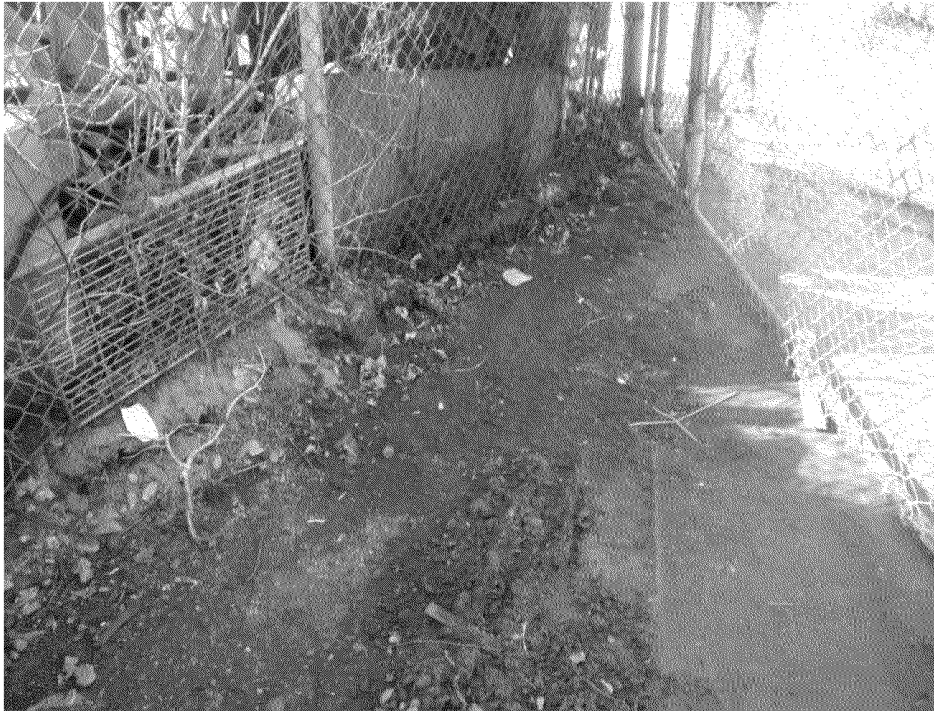
Photograph 73. View from the outside of the perimeter fence showing staining.

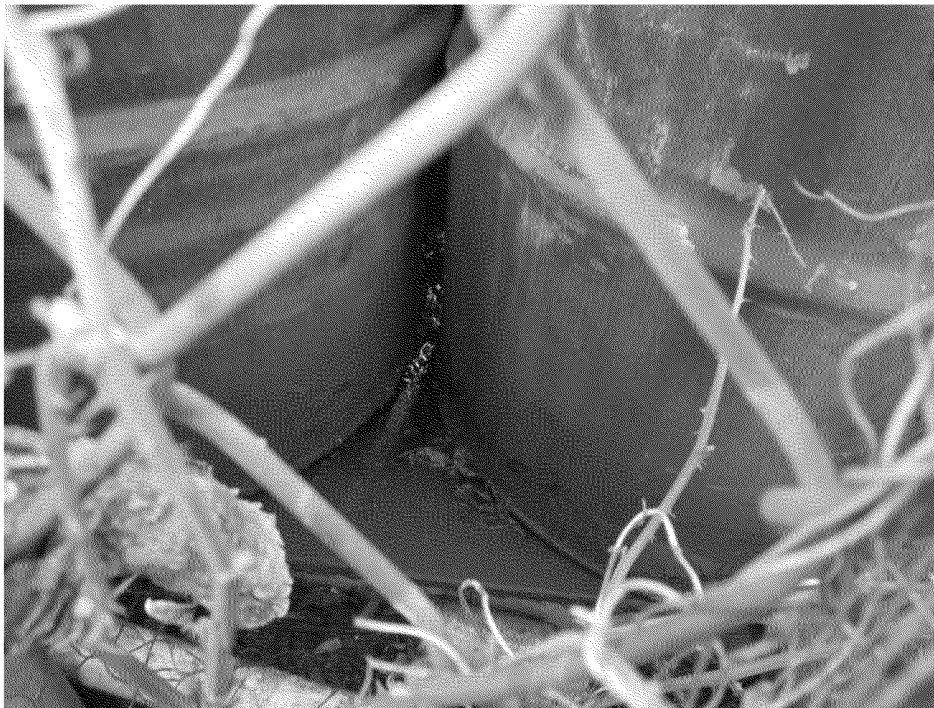
Photograph 74. Close-up view of two barrels containing used oil filters sitting on top of secondary containment . Containment is adjacent to the berm.

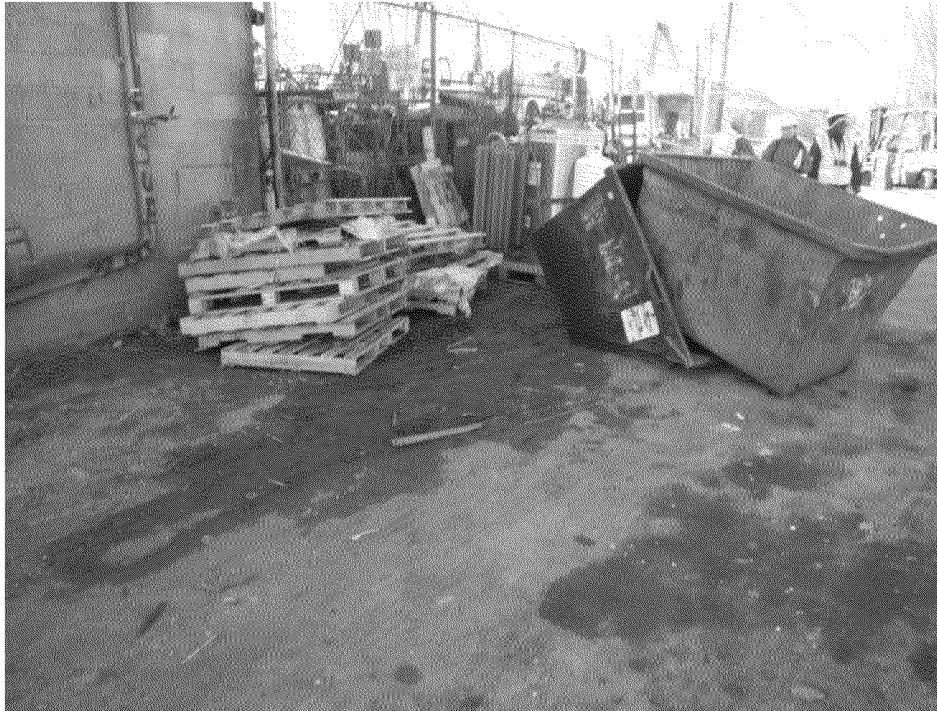
Photograph 75. **Staining on the ground outside of the perimeter fence near dumpsters.**

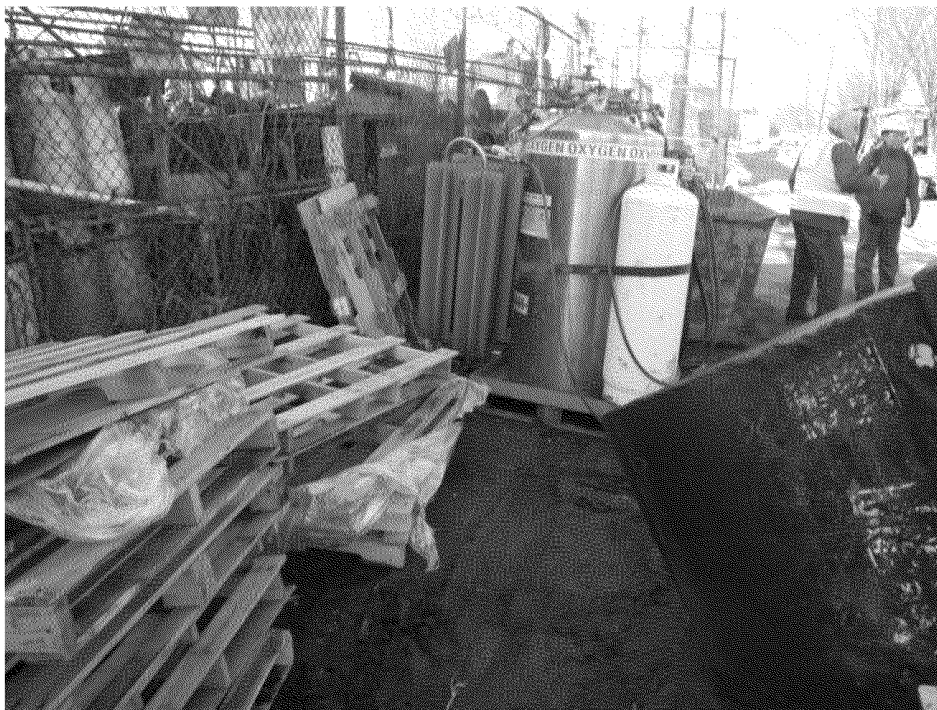
Photograph 76. **View of items stored the outside of the perimeter fence.**

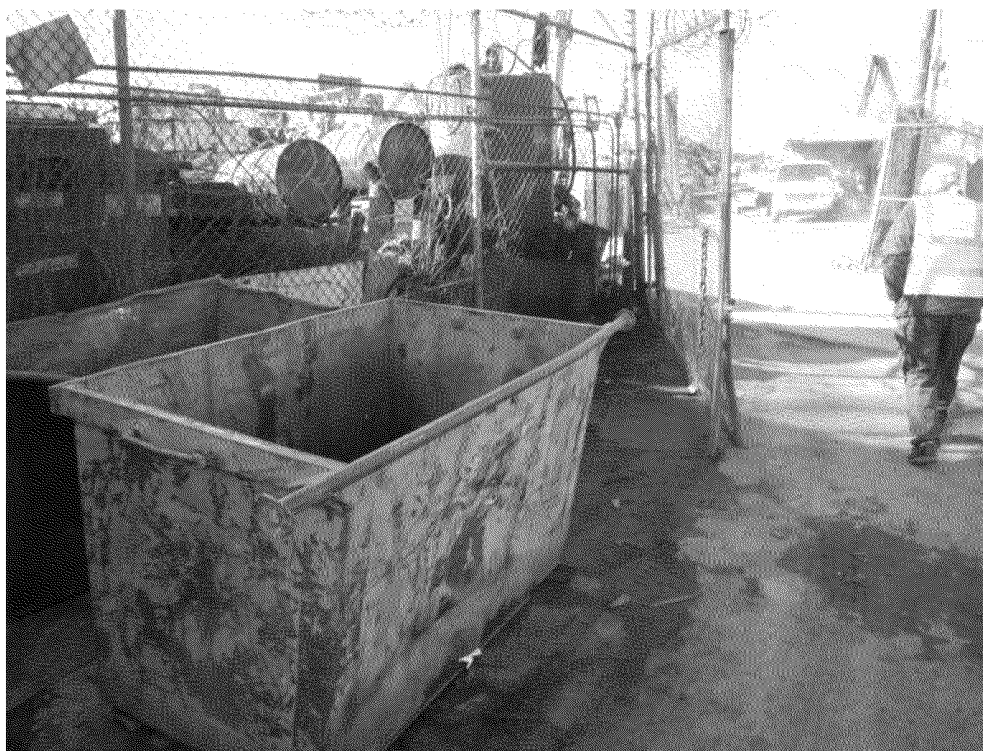
Photograph 78. **Staining and old dumpsters near Entrance 1.**

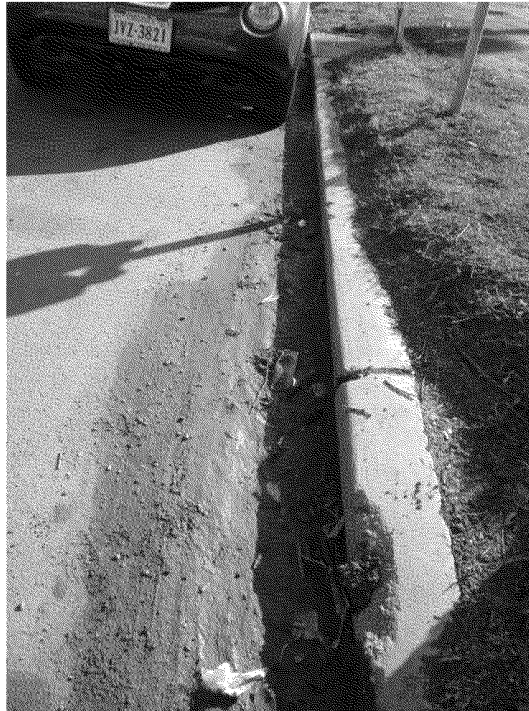
Photograph 79. Path of sediment leading from Super Salvage towards the storm drain.
Storm drain is located near the corner of First Street SW and S Street SW.
